RESEARCH MEMORANDUM

EXPERIMENTAL INVESTIGATION OF THE VIBRATION CHARACTERISTICS

OF FOUR DESIGNS OF TURBINE BLADES AND OF THE EFFECT

By W. C. Morgan and C. R. Morse

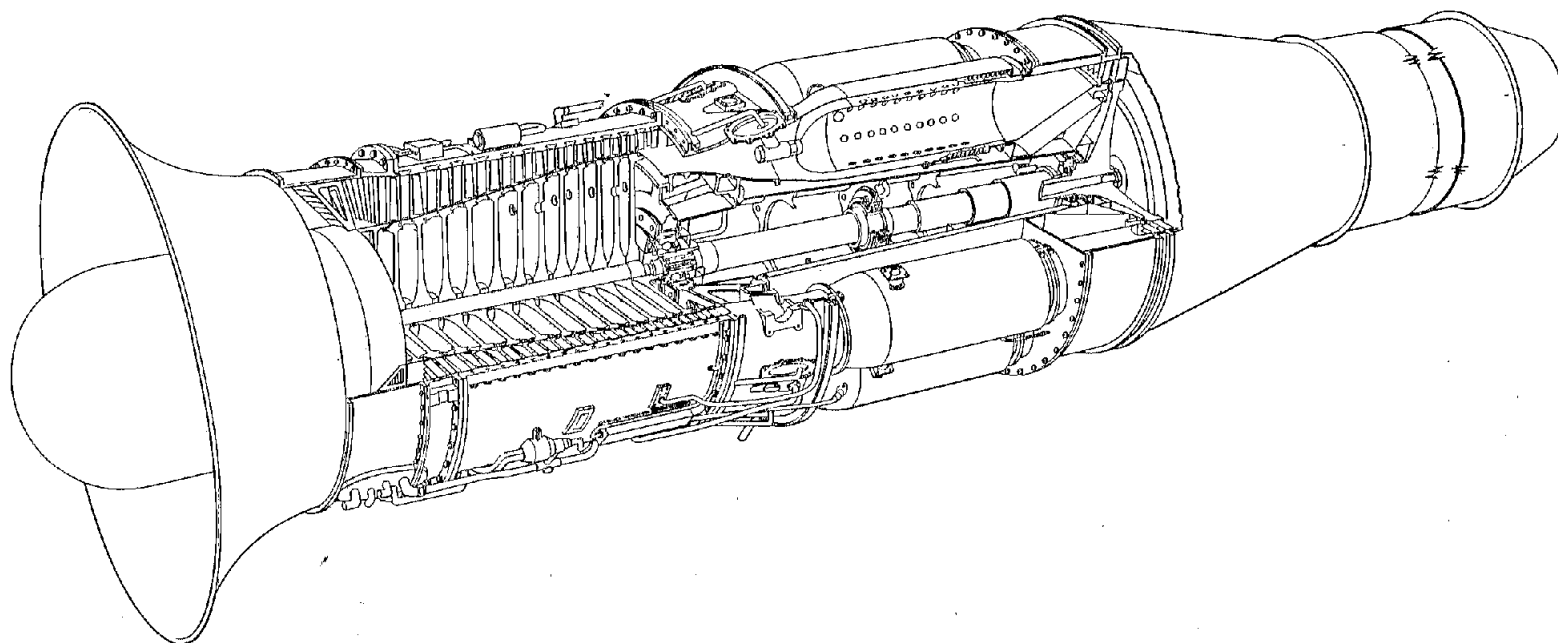
Figure 1. - Cutaway sketch showing principal components of turbojet engine.

Description of engine. - A representation of the turbojet engine used in the investigation is shown in figure 1. The turbine section consisted of a single-stage rotor with eight cylindrical combustors mounted symmetrically around the aft frame; there were 64 equally spaced stator blades in the nozzle assembly.

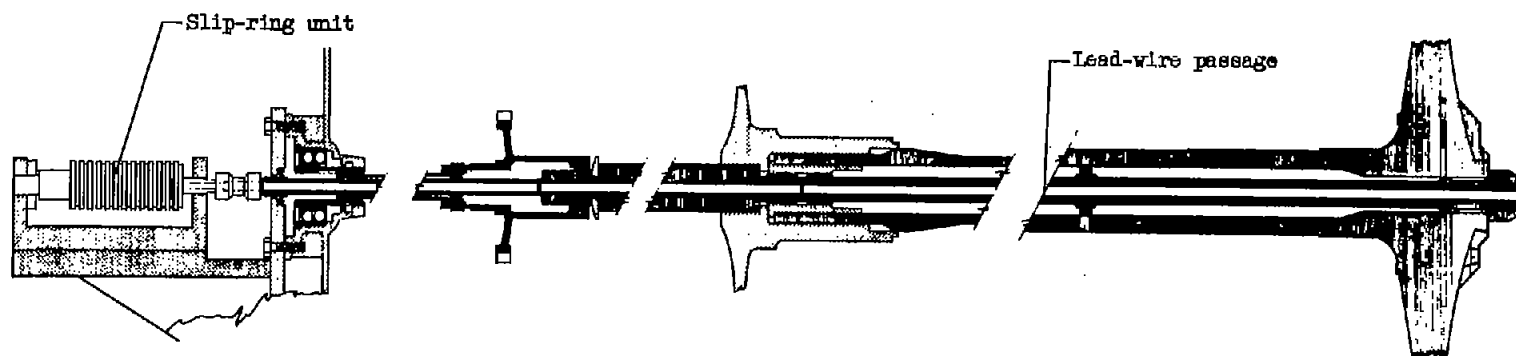
Figure 2. - Sketch of alteration to engine components for lead-wire passage and slip-ring drive shaft.

Modification to engine. - The sketch shown in figure 2 indicates the modification to engine components made in order to provide a passage for lead wires from the strain-gage terminal connection on the aft face of the turbine wheel to the slip-ring rotor at the forward end of the engine. Axial holes were bored through the turbine shaft bolt, the compressor shaft, and the special slip-ring drive shaft in the accessory section.

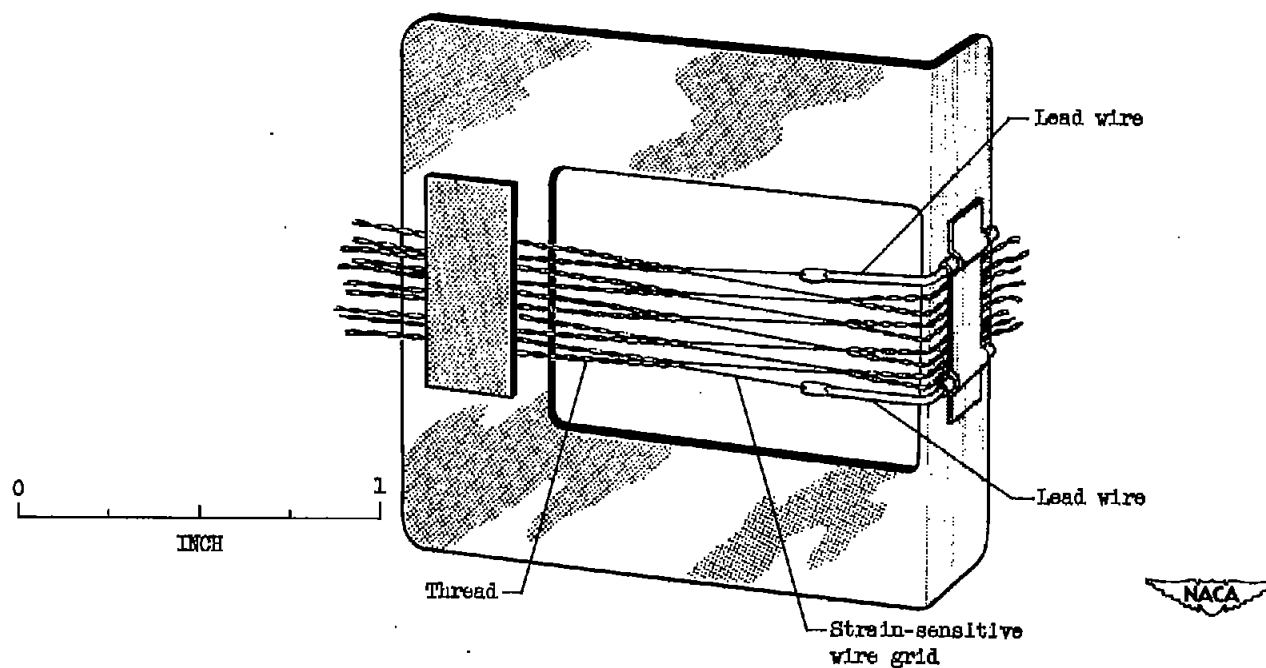
Figure 3. - High-temperature wire-resistance strain gage in frame ready for mounting.

Strain-gage instrumentation. - The data were obtained from high-temperature resistance-wire strain gages mounted on the turbine blades. The techniques of fabrication and mounting of these strain gages are described in references 5 and 6. A sketch of a strain gage prior to mounting is shown in figure 3.

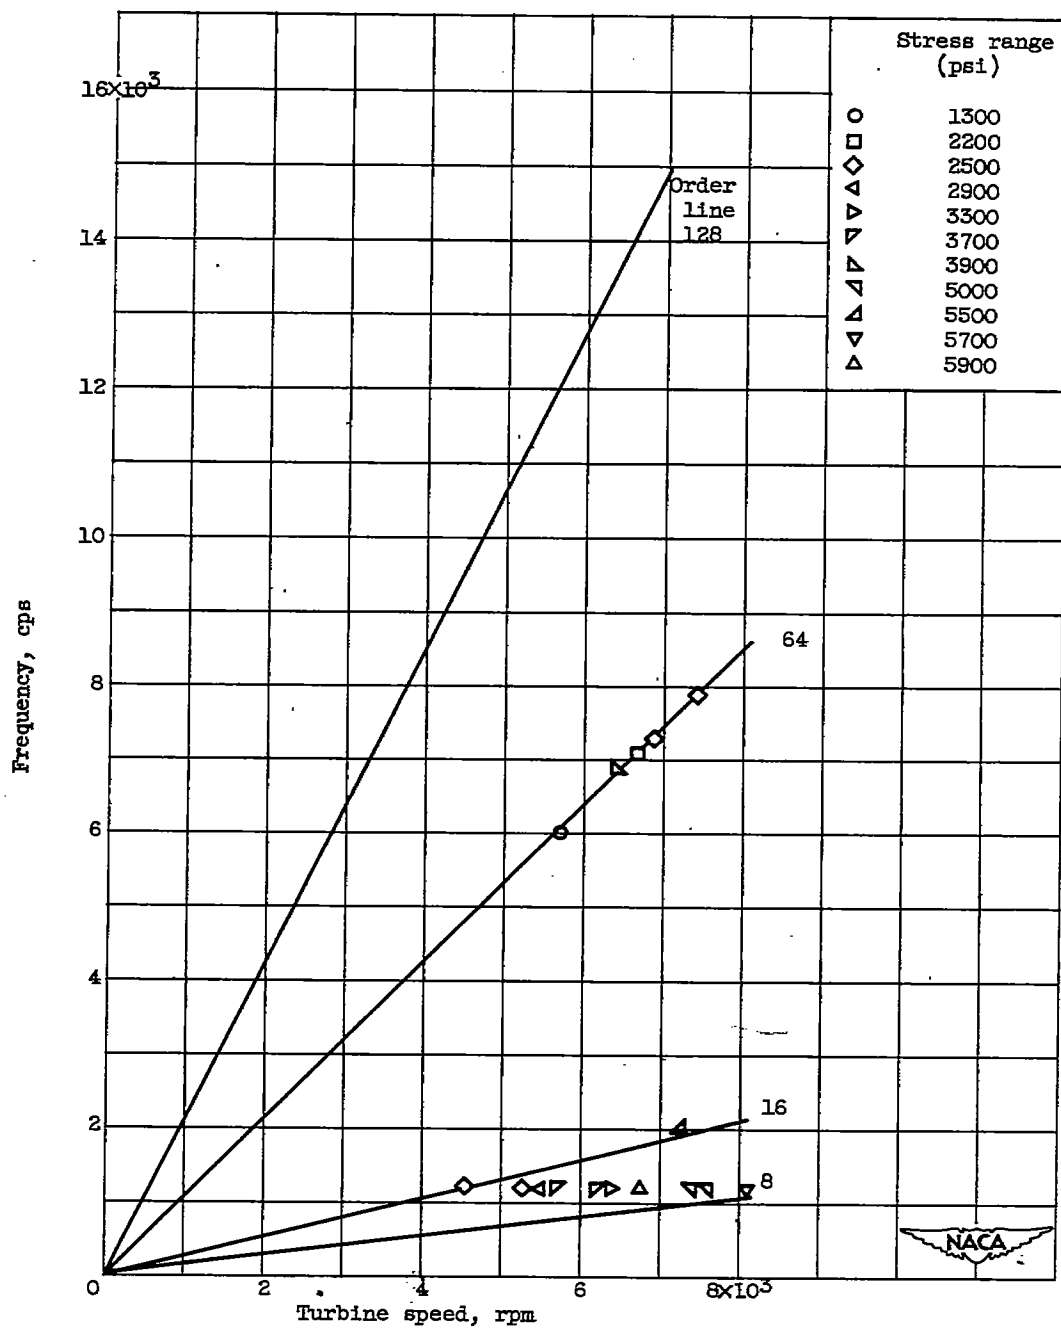
(a) Position 1 ($1\frac{1}{4}$ -in. spacing).

Figure 7. - Critical-speed diagram of vibration in design A turbine blade.

The critical speed diagrams for positions 1, 2, and 3 of turbine blade A (fig. 7(a), 7(b), and 7(c), respectively) show that there was an appreciable effect on vibration as a result of the change in spacing. In position 1, the first-bending mode was the predominant vibration. Only one case was observed of excitation of the first-torsional mode. There were several occurrences of complex-mode vibration.

The first-bending mode was susceptible to excitation at many orders of turbine speed not predictable from an analysis of engine geometry. The first-torsional mode appeared near the second harmonic of the

combustors. The fundamental order of the nozzle blades excited the more complex modes.

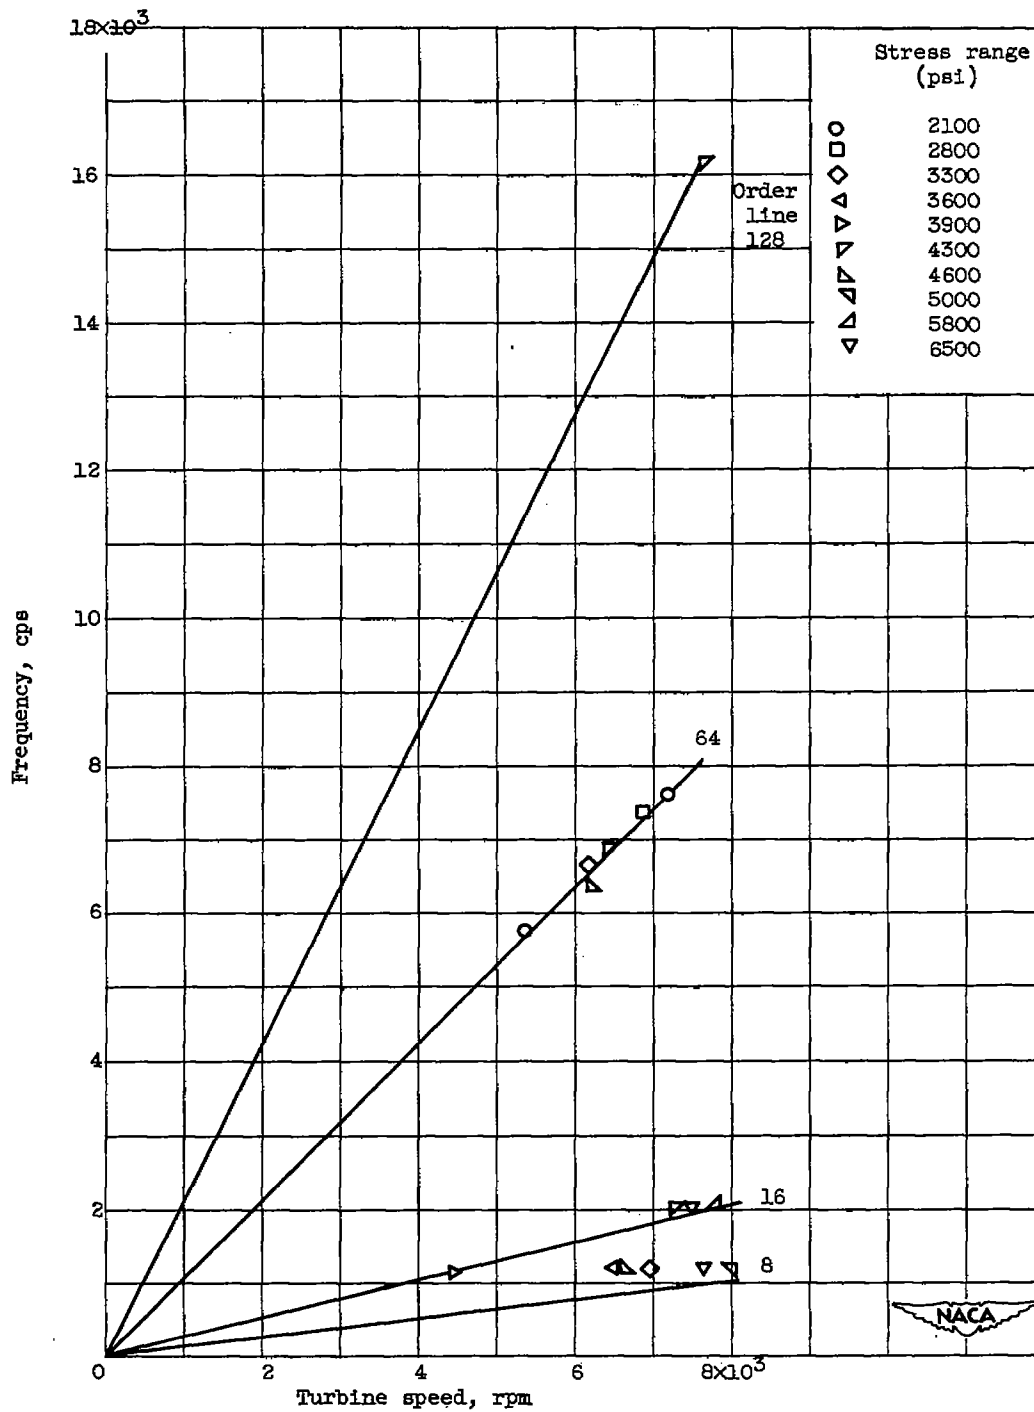
(b) Position 2 (1-in. spacing).

Figure 7. - Continued. Critical-speed diagram of vibration in design A turbine blade.

In position 2, a comparatively lesser number of vibrations were observed for the first-bending mode. There was an increased tendency toward vibration in the first-torsional mode, but the complex-mode vibrations were not affected to any considerable extent with the exception that one occurrence was observed of vibration at the second harmonic of the nozzle blades. Vibration in the first-bending mode appeared at close increments of speed when the turbine blade was operated in position 3. There was an increase in the occurrence of complex-mode vibration attributable to the fundamental order of the nozzle blades. Vibration was observed, also, at the second harmonic of the nozzle blades. There was an absence of detectable vibration in the first-torsional mode.

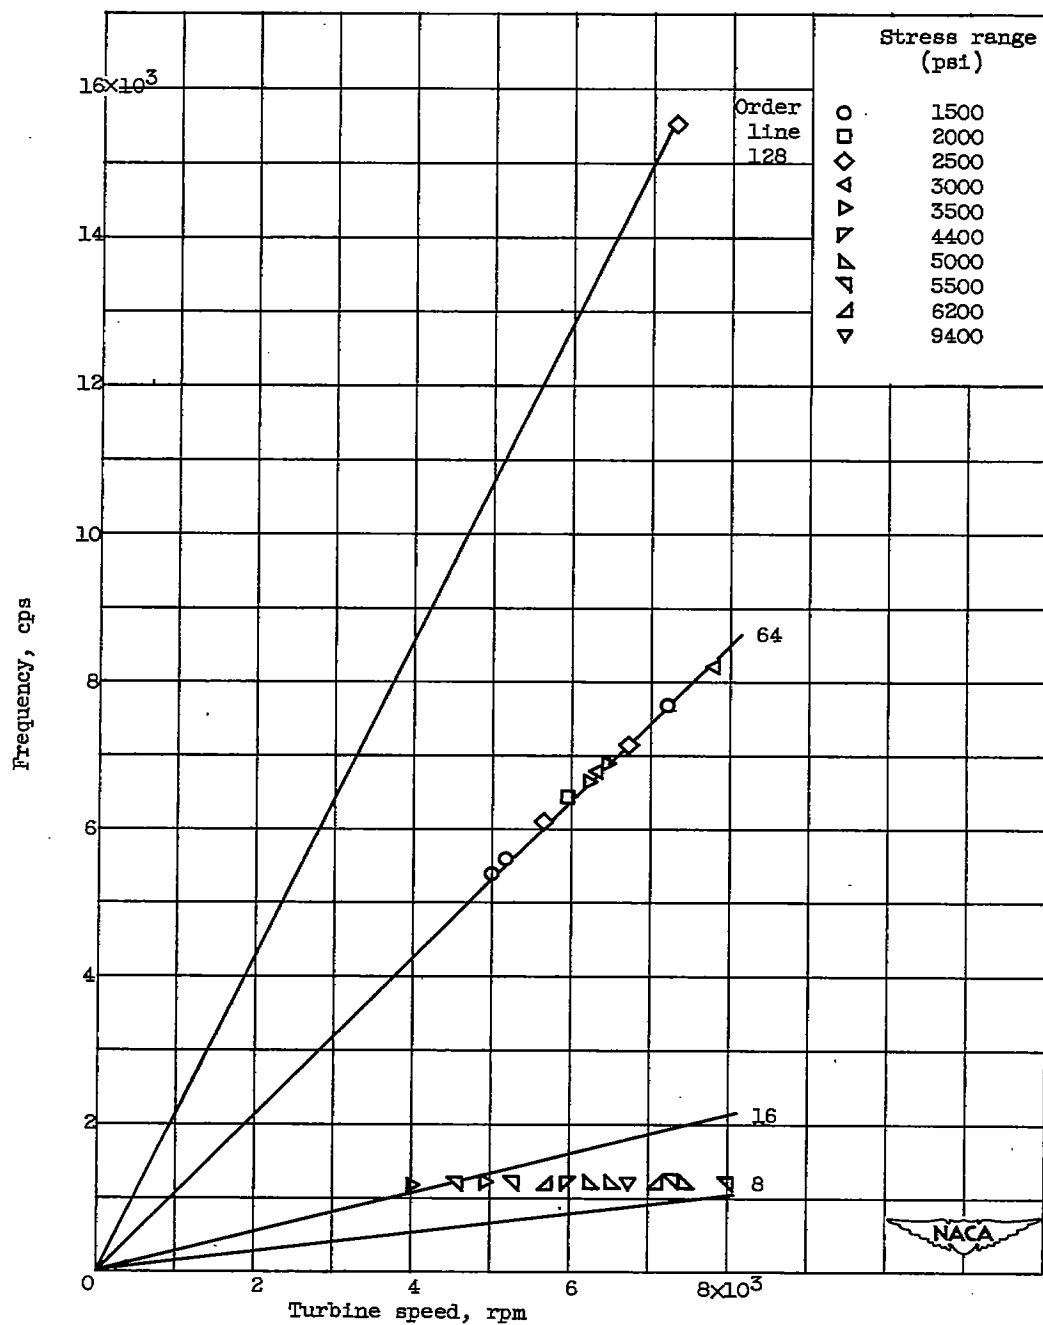
(c) Position 3 (3/4-in. spacing).

Figure 7. - Concluded. Critical-speed diagram of vibration in design A turbine blade.

For the first-bending mode, a trend toward increase in stress level was observed with decrease in nozzle-blade-to-turbine-blade spacing. The peak stress for first-torsional mode vibration occurred at position 2. This was true, also, for the complex-mode vibration. These results must be considered only qualitative, however, because of several factors that will be discussed in a subsequent part of this report entitled FACTORS AFFECTING INTERPRETATION OF STRAIN-GAGE DATA.

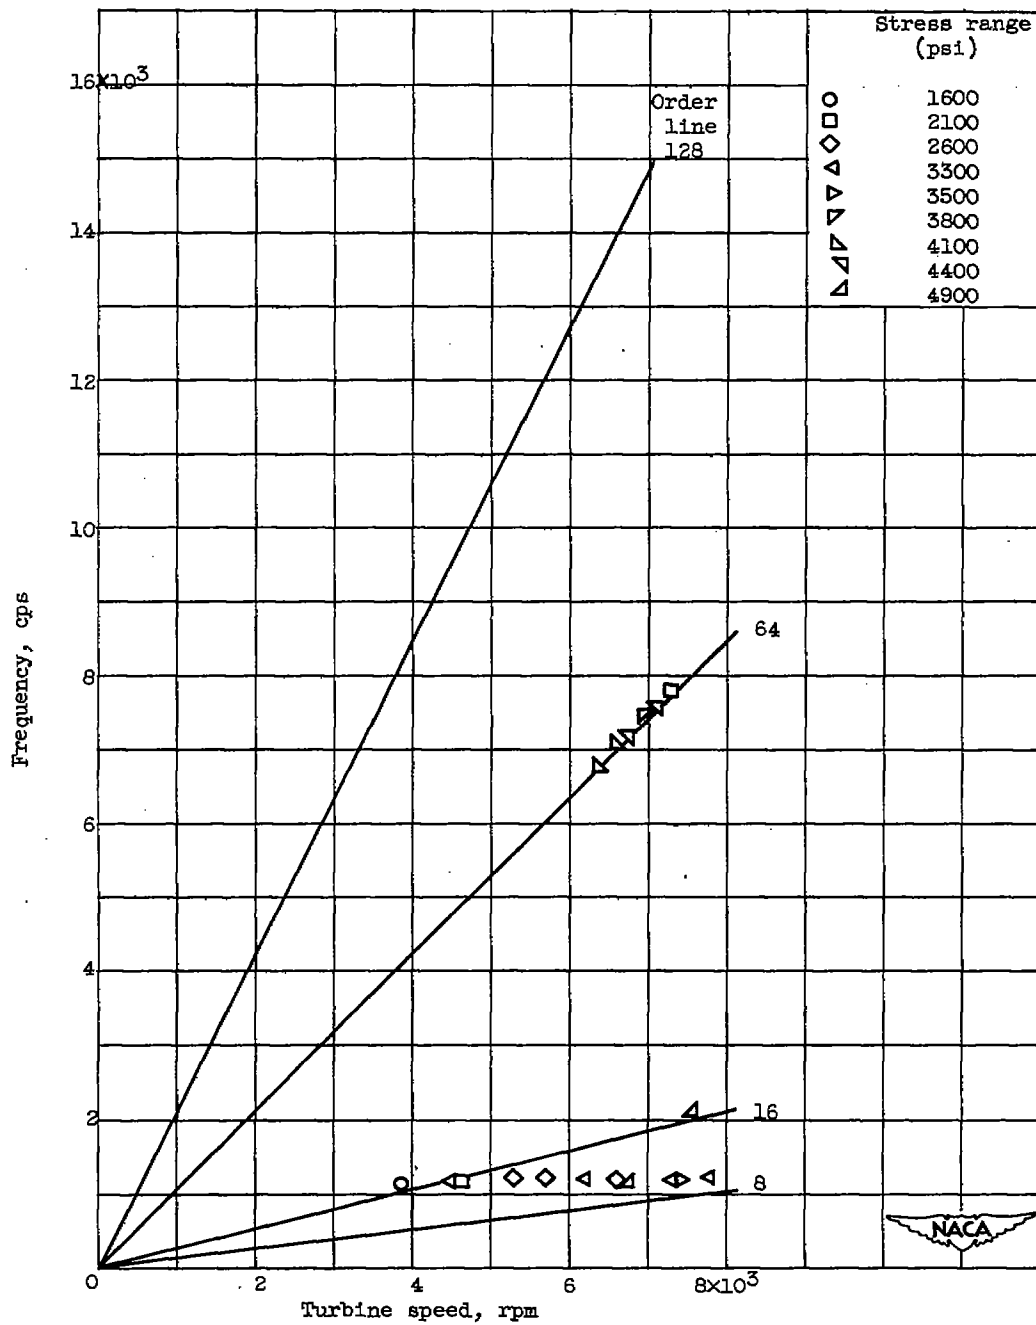
(a) Position 1 ($1\frac{1}{4}$ -in. spacing).

Figure 8. - Critical-speed diagram of vibration in design B turbine blade.

The critical speed diagrams obtained for this turbine blade at positions 1, 2, and 3 (fig. 8(a), 8(b), and 8(c), respectively) indicate that the vibration characteristics of the design B blade were generally similar to those described in the case of turbine blade A. In position 1, the first-bending mode was excited into vibration at orders of turbine speed not attributable directly to engine configuration. Vibration in the first-torsional mode occurred at only one speed, probably as a result of second-harmonic combustor excitation.

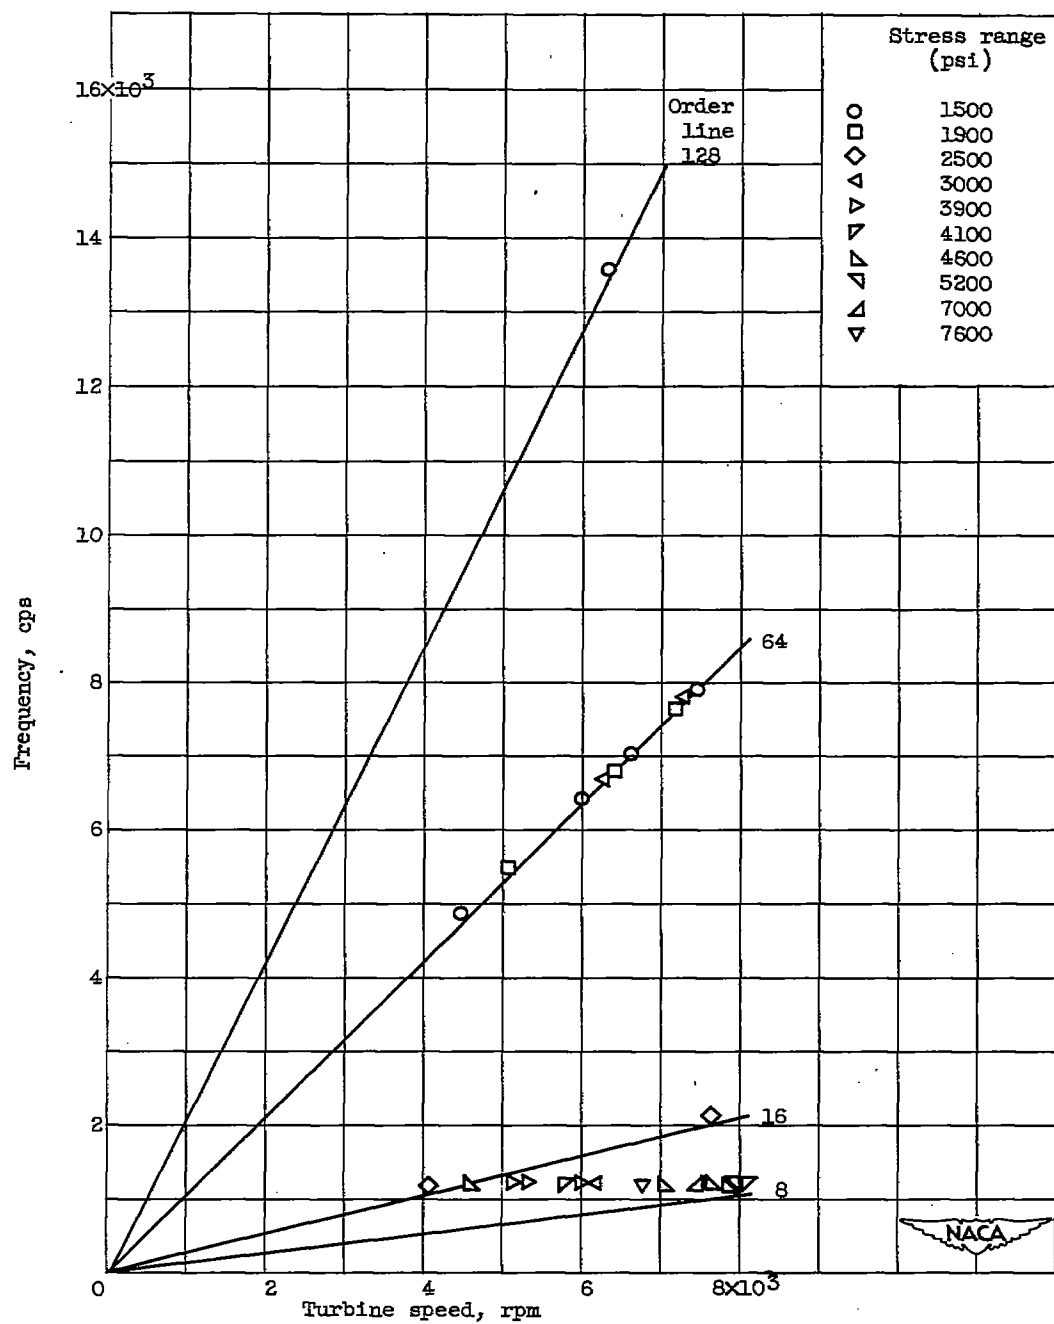
(c) Position 3 (3/4-in. spacing).

Figure 8. - Concluded. Critical-speed diagram of vibration in design B turbine blade.

The design B turbine blade displayed less change in vibration characteristics with decrease in spacing than any of the other three designs. The occurrence of vibration in position 3 was not markedly different from that observed in the case of position 2. High-frequency vibration occurred only once at the second harmonic of the nozzle blades.

For vibration in the first-bending mode, the stress level increased with the change from position 1 to position 2. There was no significant difference in the stress levels measured at position 2 and position 3. The peak stress for first-torsional mode vibration occurred in position 2. In the case of complex-mode vibration, the peak stress occurred at the position of maximum spacing.

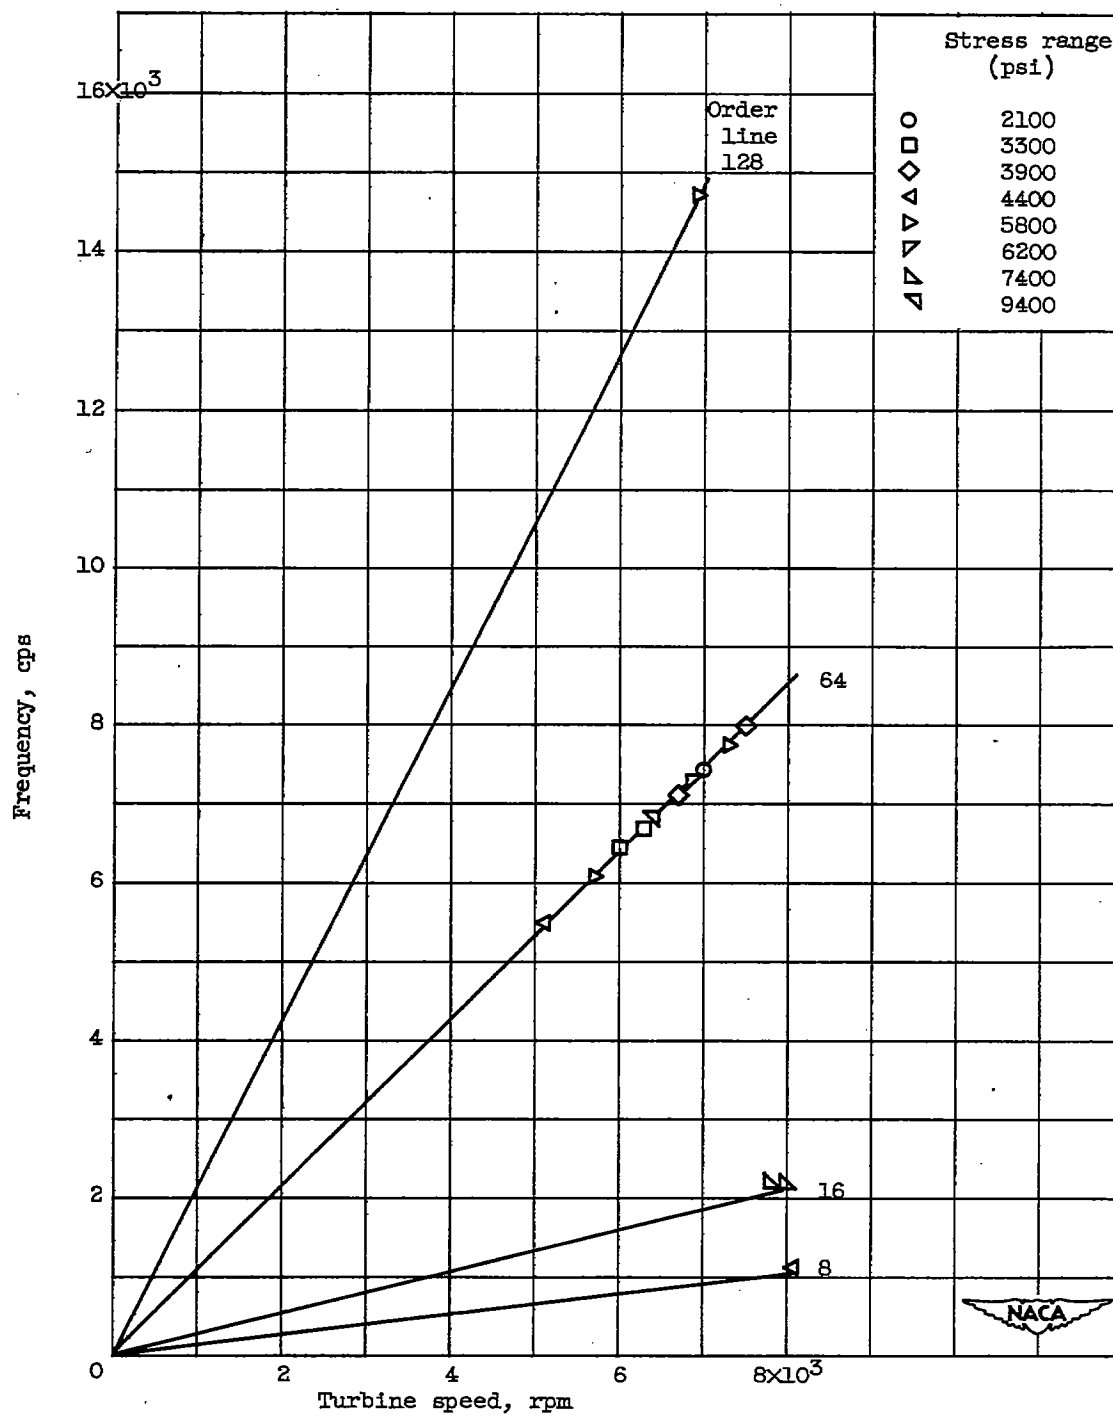
(a) Position 1 ($1\frac{1}{4}$ -in. spacing).

Figure 9. - Critical-speed diagram of vibration in design C turbine blade.

The critical speed diagrams for the design C turbine blade in positions 1, 2, and 3 are shown in figures 9(a), 9(b), and 9(c), respectively. These figures indicate that the progressive decrease in spacing had a considerable effect on the vibration characteristics. In position 1, vibration was almost absent in the first-bending mode. Only one case was noted of this mode of vibration at the first order of excitation attributable to the combustors. There were two cases of vibration in the first-torsional mode. The remainder of the vibrations were complex modes ascribable to the fundamental nozzle-blade order of excitation, with one exception of high-frequency vibration caused by second-harmonic nozzle-blade excitation.

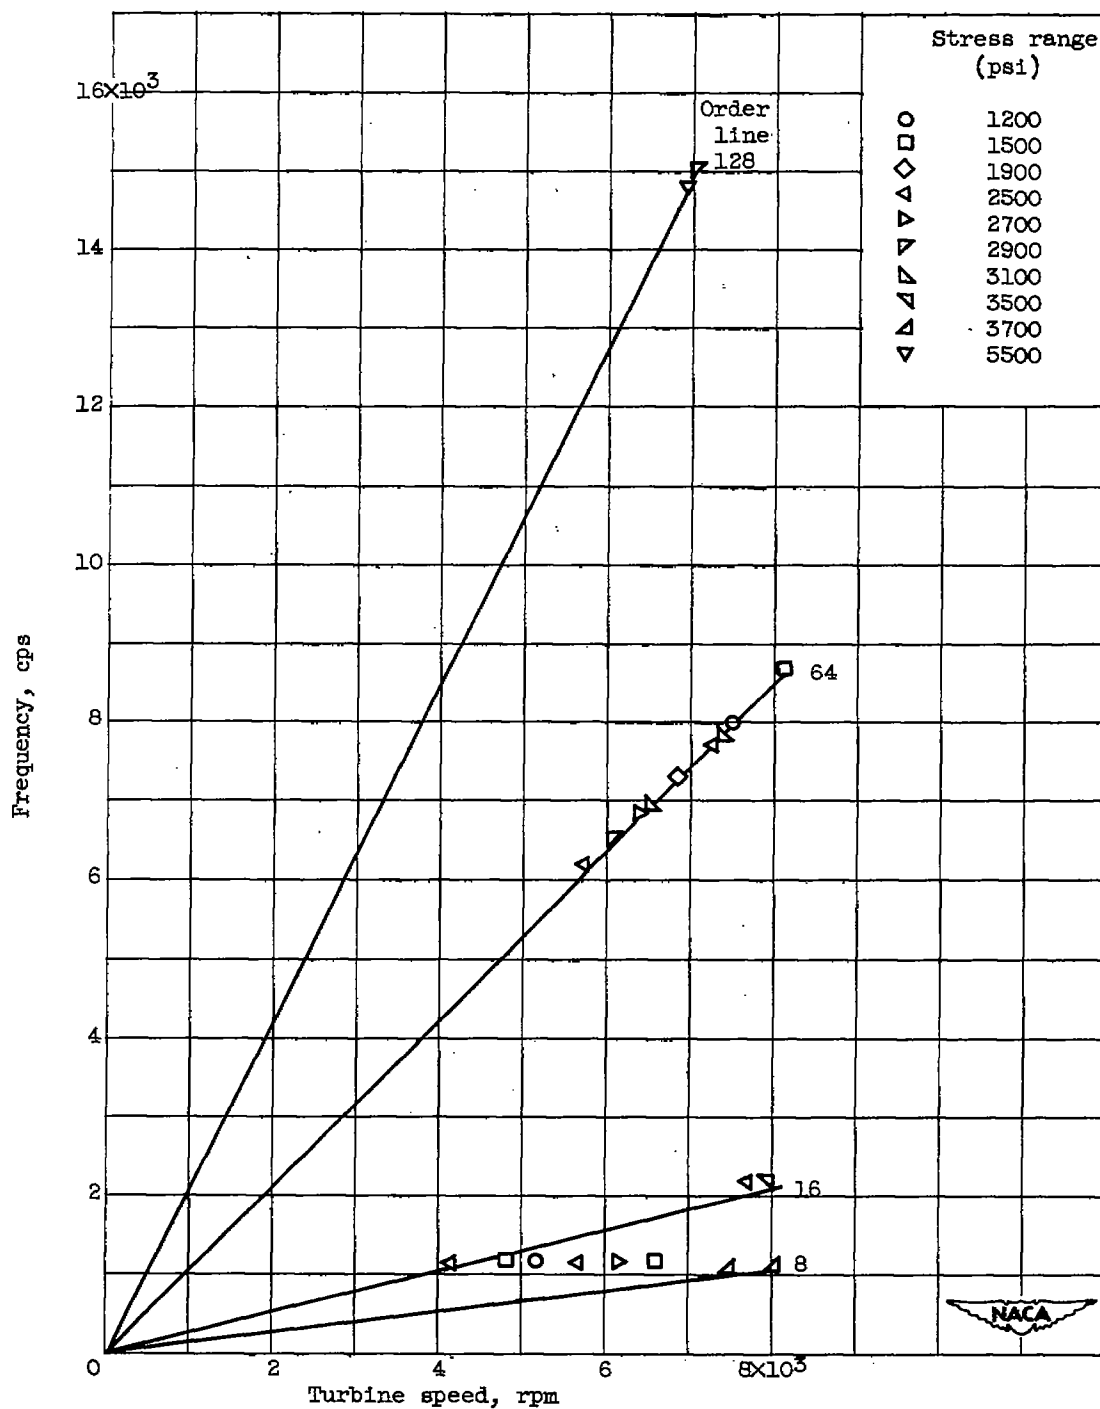
(b) Position 2 (1-in. spacing).

Figure 9. - Continued. Critical-speed diagram of vibration in design C turbine blade.

When the turbine blade was operated at position 2, the first-bending mode was excited into vibration by orders ranging from 8 to 16, inclusive. This increase of first-bending mode vibration was the principal change effected by the decrease in spacing from position 1 to position 2. The response to excitation of the first-torsional and more complex modes of vibration was not changed to any considerable extent by the decrease in spacing.

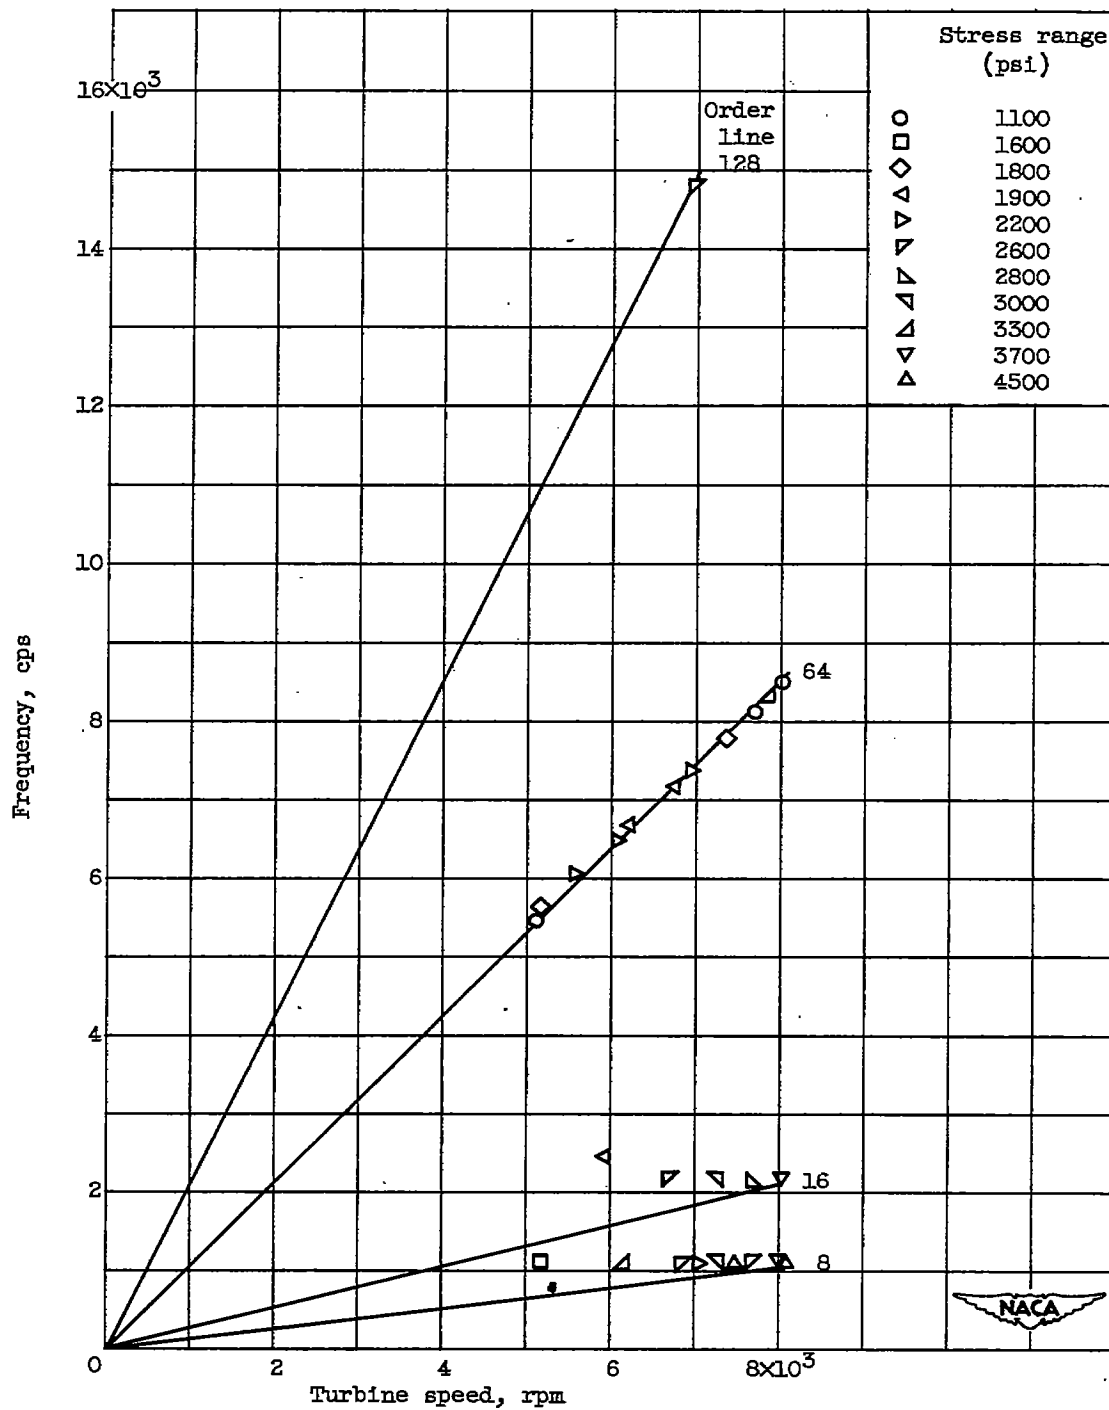
(c) Position 3 (3/4-in. spacing).

Figure 9. - Concluded. Critical-speed diagram of vibration in design C turbine blade.

Operation of the turbine blade in position 3 was observed to have changed the vibration characteristics in the first-torsional mode of vibration. Several occurrences of this mode were not directly attributable to engine configuration. In addition to this change, one case was observed of vibration in a mode of a frequency slightly higher than the first-torsional mode. This mode of vibration did not occur during previous operation of the design A and design B blades or of the design C blade in position 1 and position 2. The complex-mode vibrations observed were similar in nature to those excited at positions 1 and 2 by the fundamental and second-harmonic orders of the nozzle blades.

In the first-bending mode, the highest stress occurred at minimum spacing; in first-torsional mode, at maximum spacing; and in the complex modes, also at the condition of maximum spacing.

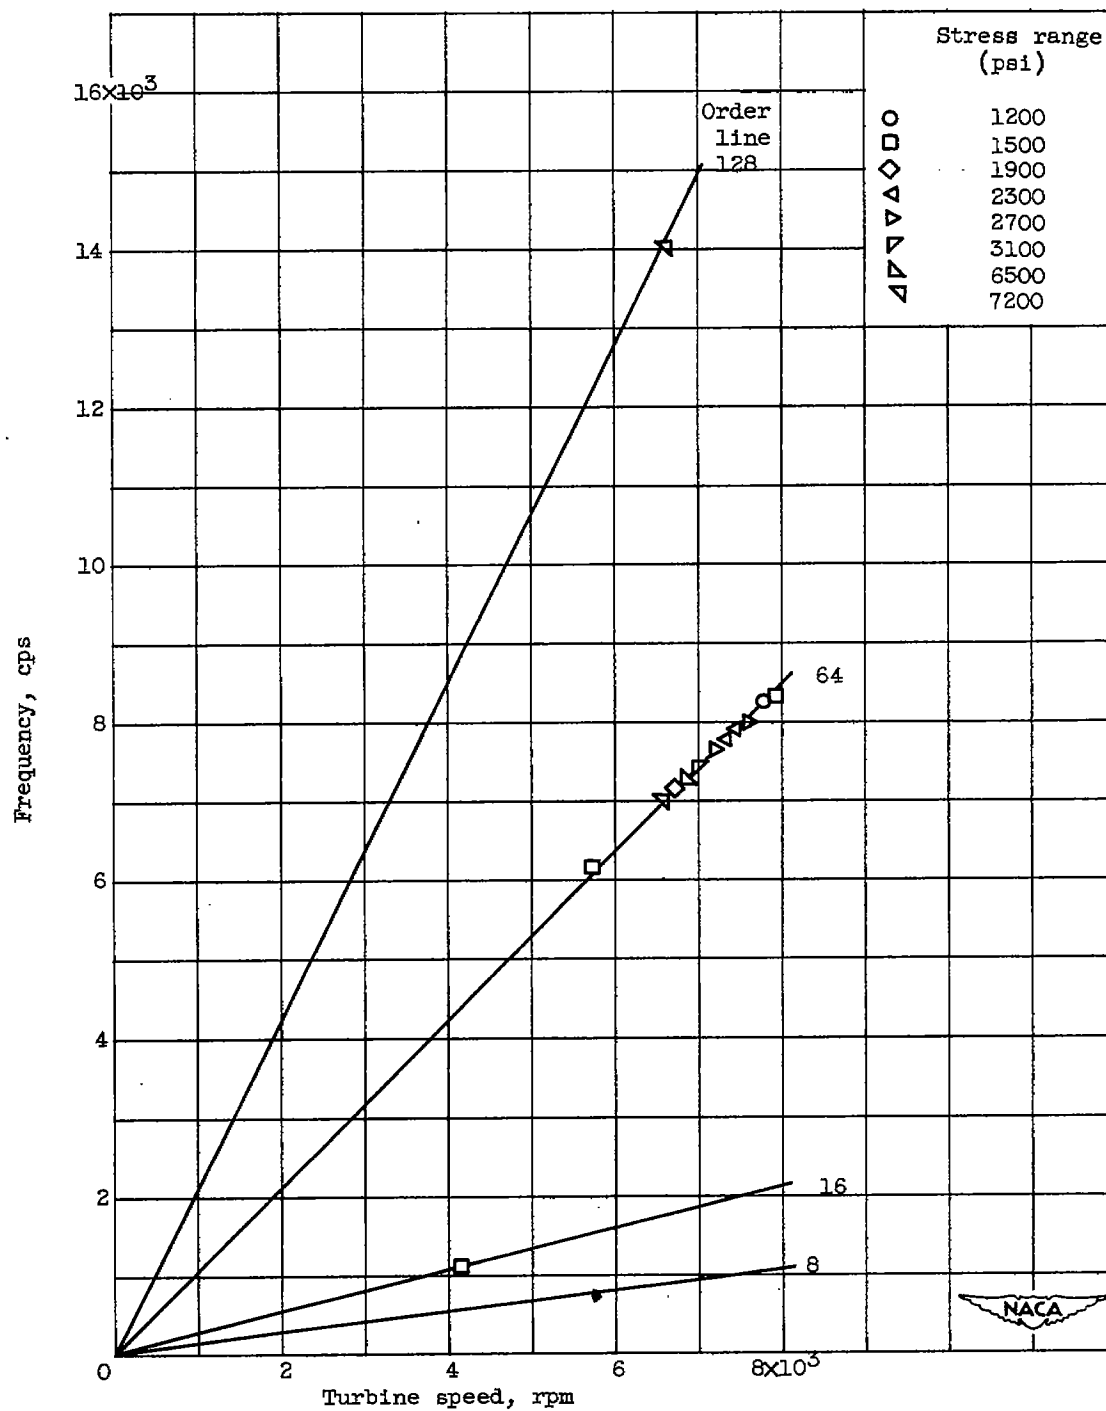
(a) Position 1 ($1\frac{1}{4}$ -in. spacing).

Figure 10. - Critical-speed diagram of vibration in design D turbine blade.

The progressive decrease in spacing was accompanied by changes in vibration characteristics that were similar, in general, to those observed in the case of the design C turbine blade. The critical speed diagrams for positions 1, 2, and 3 are shown in figures 10(a), 10(b), and 10(c), respectively.

In position 1, the first-bending mode of vibration was excited at only one speed and by the second-harmonic order of the combustors. The first-torsional mode was not observed to occur. These were the principal disparities between the vibration characteristics of the designs C and D blades. Complex modes appeared as a result of excitation by the fundamental and second-harmonic orders of the nozzle blades.

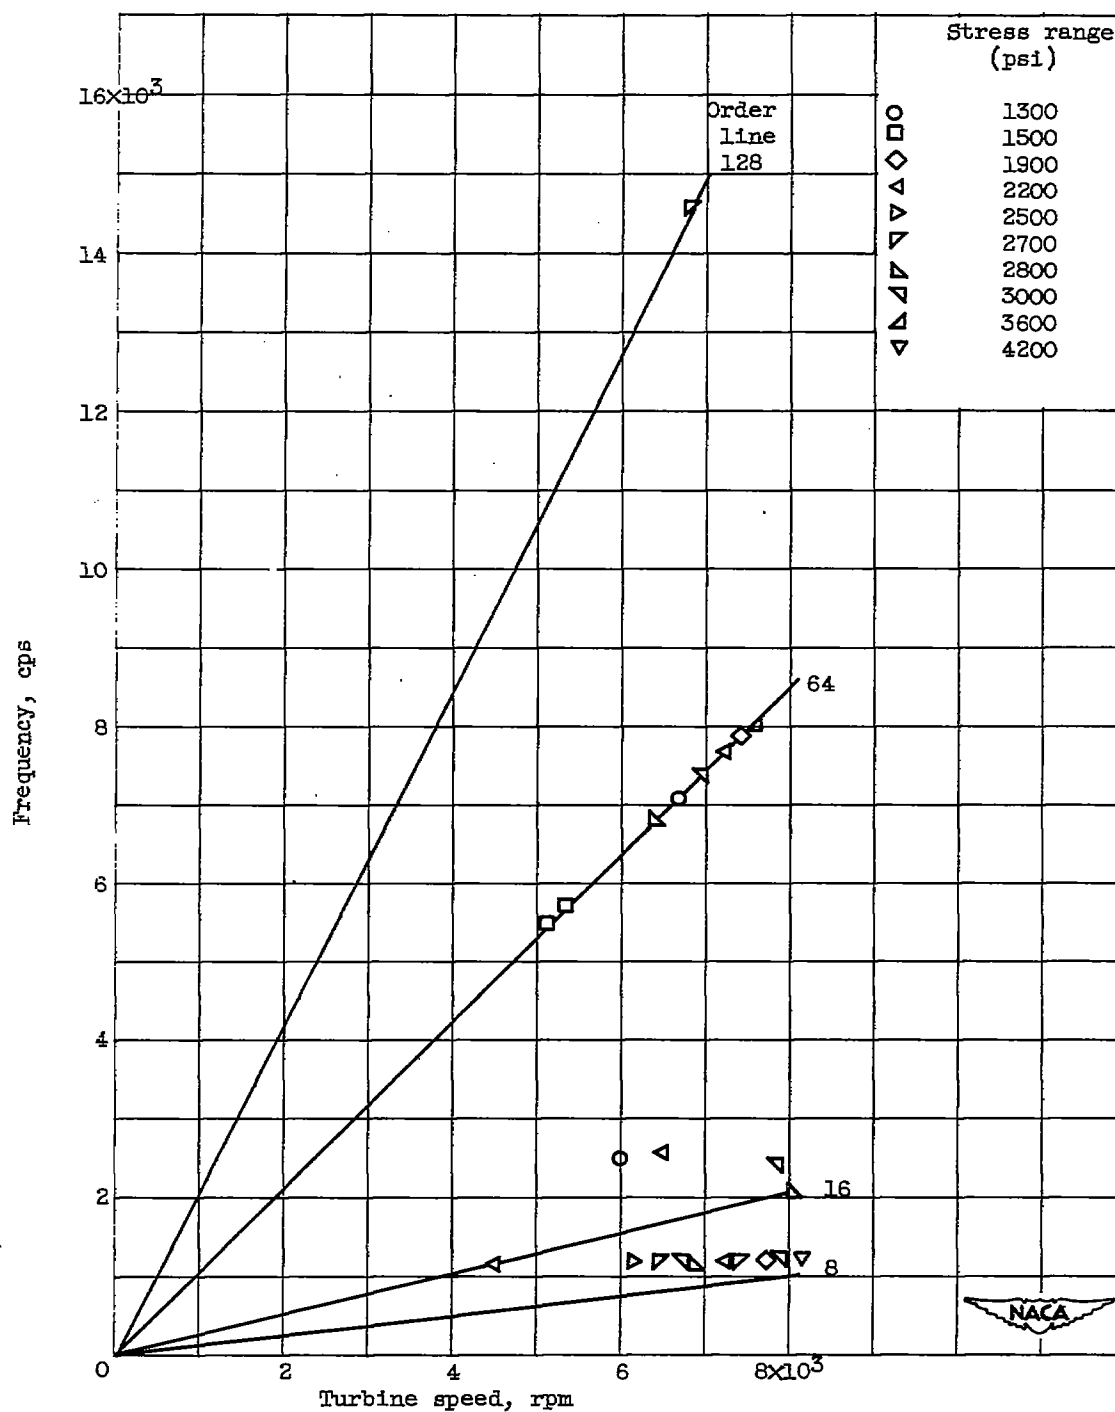
(b) Position 2 (1-in. spacing).

Figure 10. - Continued. Critical-speed diagram of vibration in design D turbine blade.

When the turbine blade was operated in position 2, a considerable change was produced in the vibration characteristics. Numerous occurrences of first-bending mode vibration were observed, and one instance occurred of vibration in the first-torsional mode.

In addition, a complex mode of a frequency slightly higher than that of first-torsional mode vibration occurred at three turbine speeds. Higher-frequency complex modes were excited by the fundamental and second-harmonic orders of the nozzle blades.

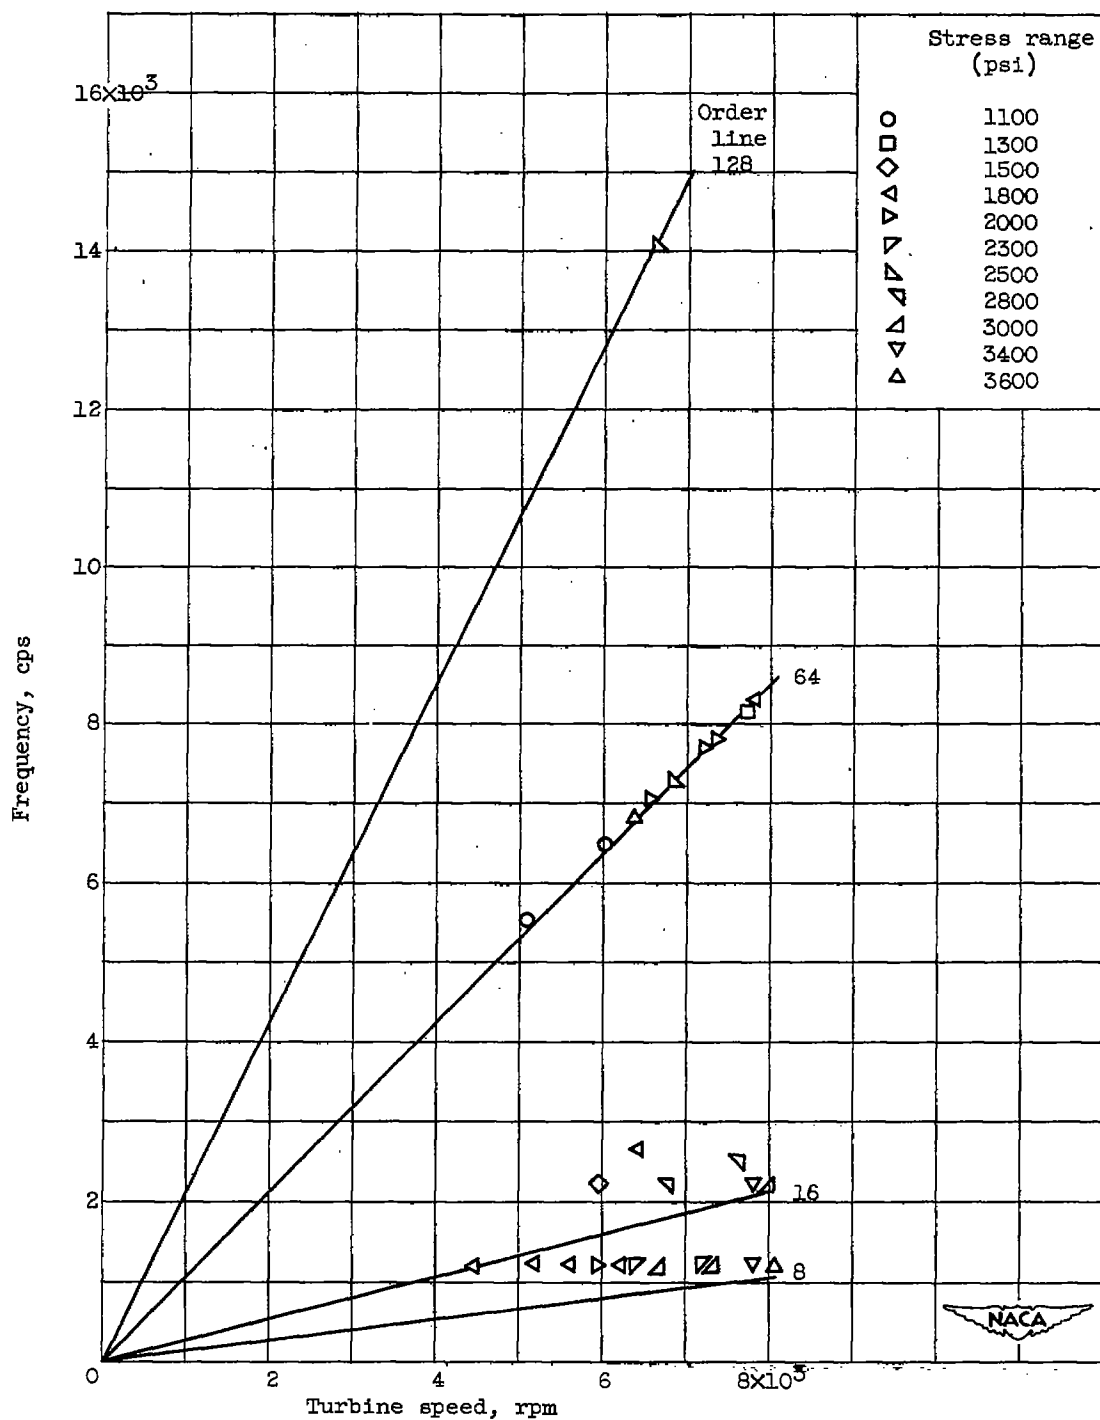
(c) Position 3 (3/4-in. spacing).

Figure 10. - Concluded. Critical-speed diagram of vibration in design D turbine blade.

The change produced by decreasing the spacing to position 3 was, to some extent, parallel to that observed for the design C turbine blade. It was characterized principally by the increase in susceptibility of the turbine blade to excitation in the first-torsional mode at orders of turbine speed not directly ascribable to engine geometry. The complex modes appeared as results of fundamental and second-harmonic nozzle-blade excitation. The first-bending mode of vibration was observed to occur at many orders of turbine speed.

For the first-bending mode, stress was highest at the condition of intermediate spacing; for the first-torsional mode, the peak stress occurred at minimum spacing. For the complex modes, peak stress occurred at maximum spacing.
